North Haven Police Department Berniere Memorial Building

Existing Building Conditions

February 2016

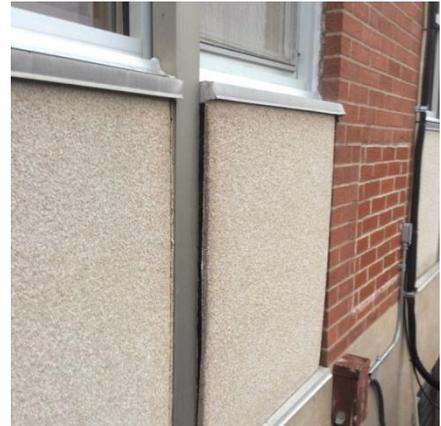
The windows to the police building were replaced in 1994. They are a typical aluminum framed insulated glass replacement window. Throughout the entire building, large gaps between the window and structure can be observed. The caulking to cover these gaps has aged and cracked. This condition provides a direct path for water to infiltrate the interior of the building. Several of the windows are visibly out of square and plumb. Several window contractors have looked at the existing windows and the only recommendation given is a complete replacement. This problem is further compounded by the presence of foam insulated stone faced panels above and below the windows. These panels have pulled away from the building and create additional paths for water. These panels cannot be repaired or replaced.

In 2014, the Town of North Haven commissioned Capital Studio Architects to design the replacement window system. Plans for replacement windows are complete. During the design process, it was discovered that PCB's are present in the caulking and remediation will be required. The window specifications and drawings are complete. Initial estimates place the project costs at over \$300,000. The compromised windows are most likely the primary source of water infiltration into the building. Interim steps, such as re-caulking has been done in areas of heavy leakage as a temporary stopgap, with limited success.

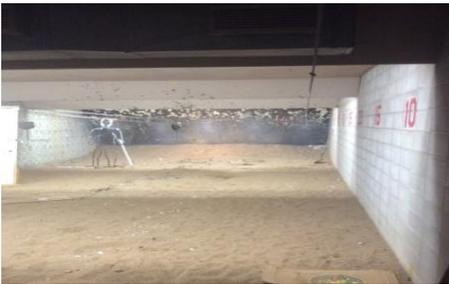
In 2014 Eagle Environmental Services completed a study of the lower level pistol range. Their analysis revealed high levels of lead within the soil as well as the backstop area of the range. Lead contamination also extended into the entrance hallway and adjoining room. Renovations and remediation of the pistol range and associated areas were designed by Capital Studios and Eagle Environmental and bid in November 2015. Only two bidders responded and the low bid was \$197,800. This exceeded the Design Team's initial estimate. This project has not advanced since the bid opening.

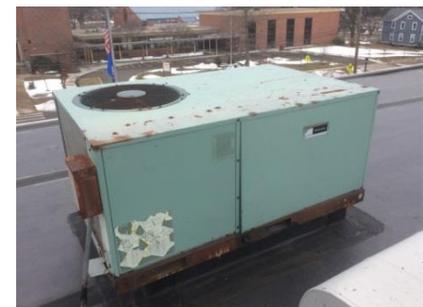
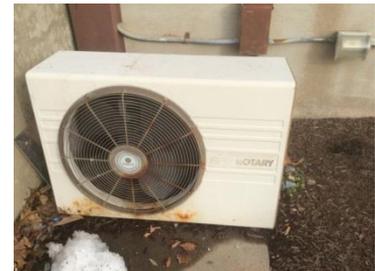
The building currently has 21 stand-alone air conditioning units. The majority are ductless split type systems and in wall traditional units. A total of three large units are in place on the roof and one on the west side ground level. There are 13 split systems throughout the building and approximately nine of these units were produced in the early 1990's. The majority of the units have approached or exceeded useful life expectancy. Two split systems are tasked with cooling the room that houses the 911 equipment, Public Safety Data Network equipment and other internal servers. These items generate heat and require that the space be cooled all times of the year. Acceptable room temperature ranges are required by the State of Connecticut and the two existing units appear to struggle to meet

the cooling demands. Four traditional window/wall units cool the Gym, Records Division, and Training Room. These units are of various ages and do not function well. The equipment struggles to maintain a comfortable environment in these areas. The units in the Physical Training Room are often turned off because the units are loud when operating. This method of cooling does not meet current design standards. Ongoing maintenance

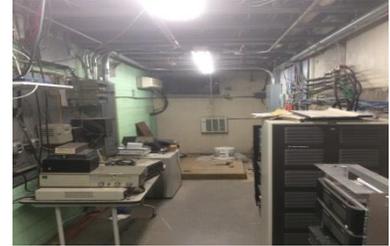
The majority of the public safety radio system is located in the basement. Unfortunately, this room is located underneath the cell block area and the associated plumbing. If a plumbing failure occur red or there was a clogged sink or toilet, the water or effluent will run into the Radio Room. Steps should to be taken to mitigate this risk.

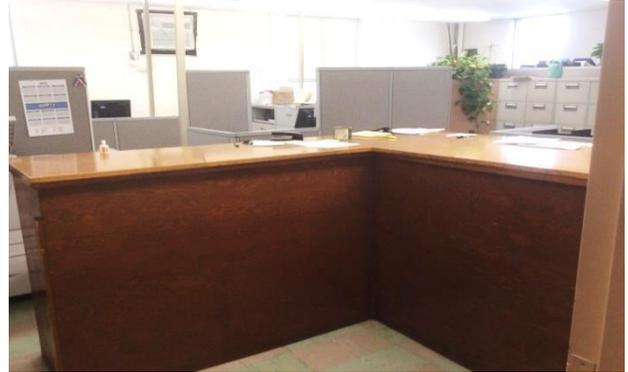
The Records Division of the Police Department is situated on the second floor near the physical training room, locker room, and the Office of the Chief of Police. The primary function of the Records Division is to provide the public with copies of official reports and issuance of permits. The location of the Records Division is problematic in many ways, but most importantly for security reasons. When the public requires access to the Records Division, the desk officer provides access into the center stairwell or elevator (by releasing the electronically controlled door) in order for them to gain access to the second floor. Once inside the Records Division Office, they are greeted by civilian staff. Only a wooden work counter separates the public from the staff. No glass enclosure or other security measures are in place. A sworn member of the Department does have a work station within the office; however, it is common for the civilian staff to be left alone throughout the day, particularly from 3:00 to 4:30 PM. Those seeking police records can sometimes be adversarial, which causes the Records Clerk to phone the Chief's Office or the Patrol Officers for security and assistance. A more suitable location for the Records Division is from the Main Lobby with the staff working behind the cover of ballistic rated service windows. It is important to consider that even with access controlled doors, once within the center stairwell of the building; access is obtained to the common hallways on all levels of the building. A fundamental part of any police building security plan seeks to limit public access to the lobby. A proposed solution would be the relocation of the records division to the first floor where the current Captains Offices are positioned.

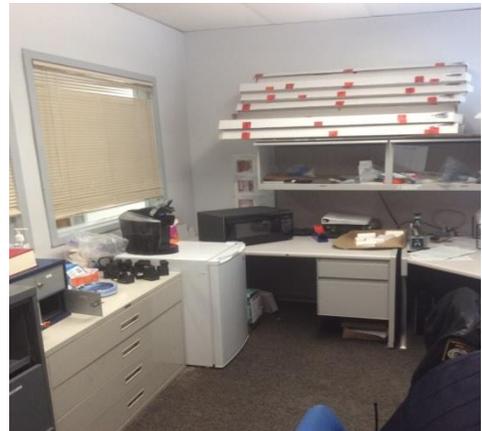
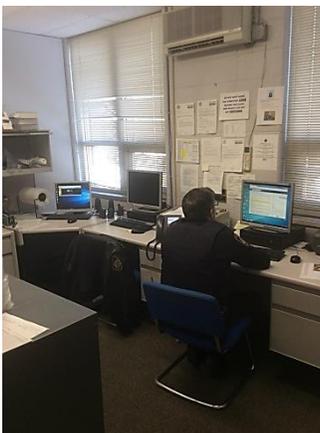
Currently, the Report Writing Room is inadequate. The space is not large enough to serve the needs of the department. Staff should be complimented for re-purposing donated work stations and cubicles for report writing, but the existing conditions are still inadequate. Relocation of this function was considered early in this process. It was thought that this space may be more suitable for Roll Call, due to its proximity to the stairwell which leads to the rear exterior of the building and subsequently the cruiser parking area.

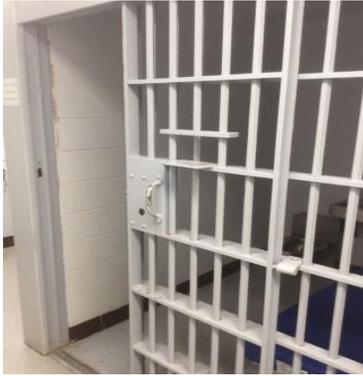
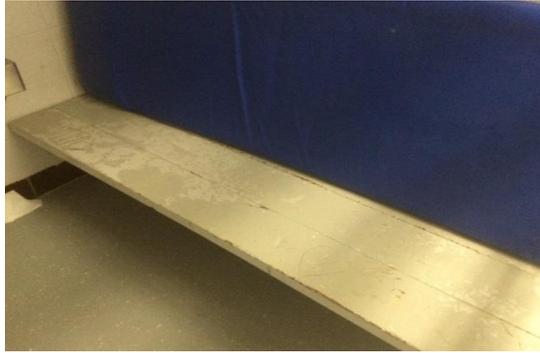
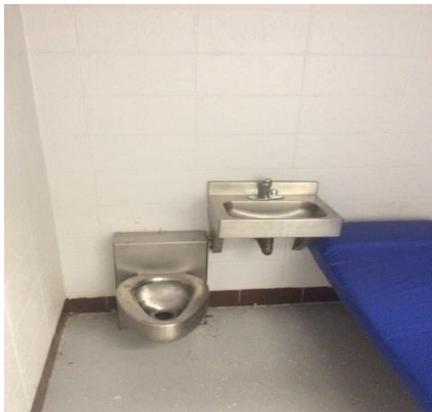
Cell block doors are of steel bar construction and do not comply with current design standards. The doors are a hanging hazard and dangerous to prisoners intent on injuring themselves. The cells should be re-designed to include new safety doors and updated cell sinks and toilets that do not expose supply lines. Additionally, one cell should include padded walls and door. The current design of the cell blocks are an important issue and should be re-designed to current standards.

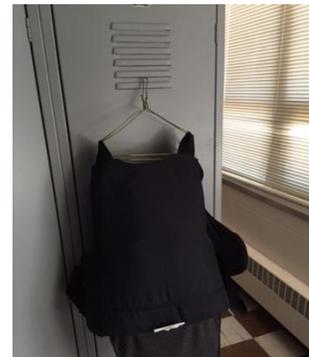
The men's and women's locker rooms are at capacity. Expansion is needed to add additional lockers for staff. Almost all current lockers are 18"x18"x60" and these do not provide adequate storage for the officer's gear. It is common for ballistic vests to be hung on the exterior of the locker door because of the need for air circulation. Contemporary police lockers are 36" wide and include a space for vest storage with ventilation, pistol security, boot draw, and an electrical outlet. The current lockers have been painted in attempts to maintain an acceptable appearance despite the functional limitations.
